I.- INTERIOR**A. - Floor Materials**

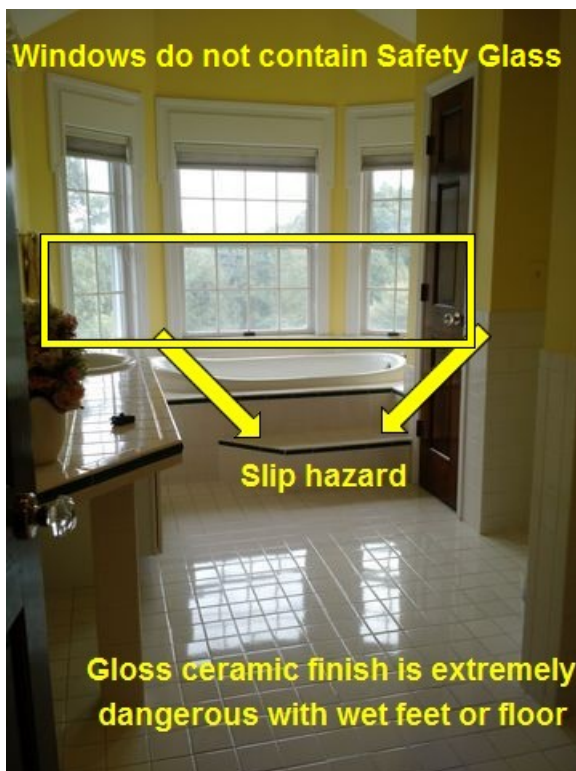
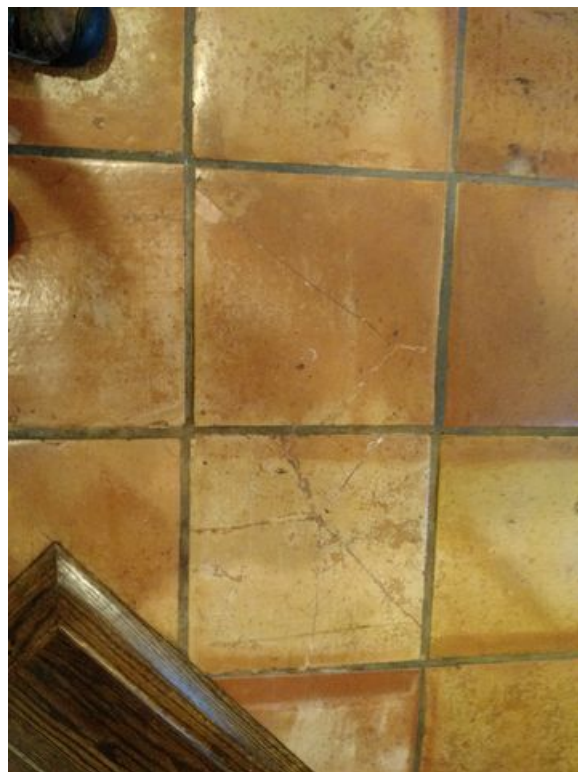
Comments: Ceramic floor tile in two upstairs bathrooms is gloss wall tile and is extremely dangerous when feet or floor is wet. This tile is also used on the steps up to the whirlpool tub. The steps is most dangerous as a slip in or out of the tub can cause a serious fall. A fall on these tiles can cause serious bodily harm. Recommend replacement with a tile manufactured for flooring immediately.

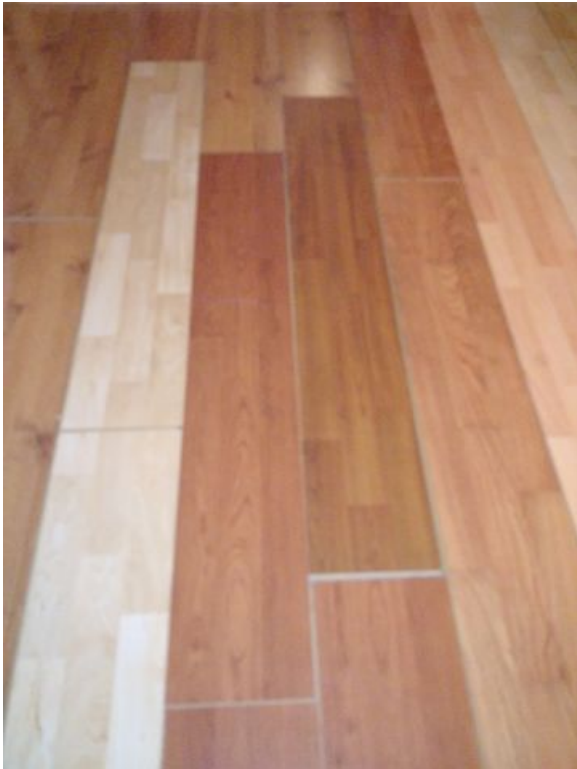
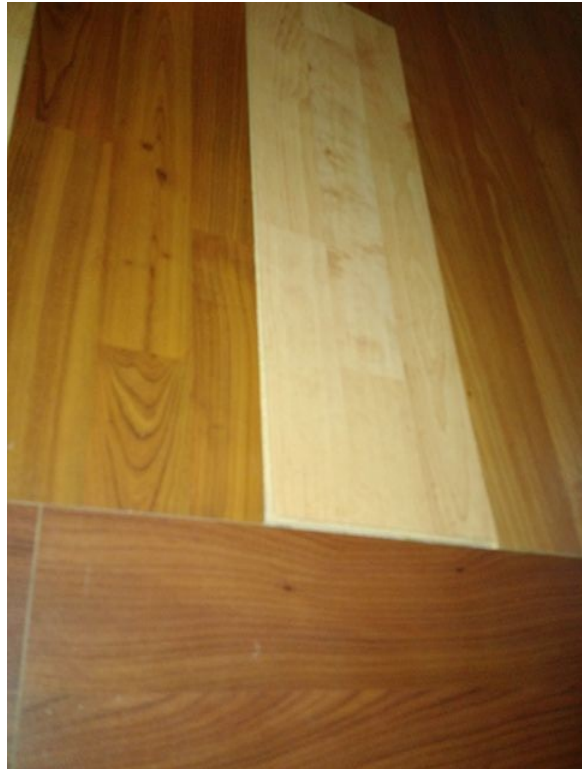
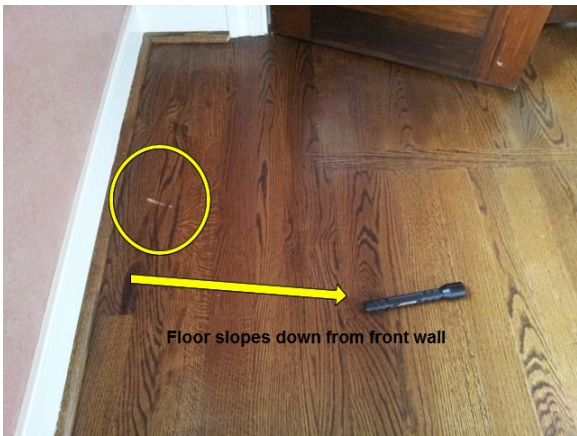
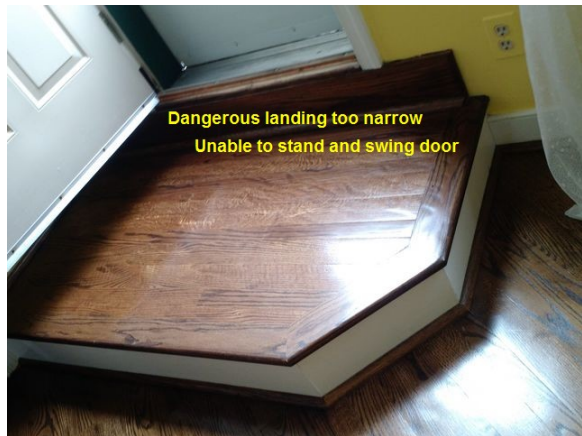
The laminate flooring in the basement is loose and not permanently secured to the sub-floor and is a multitude of trip hazards, and could cause physical injury to bare feet.
